P-51D

Walk Around Number 7
squadron/signal publications

Walk Around

P-51D Mustang

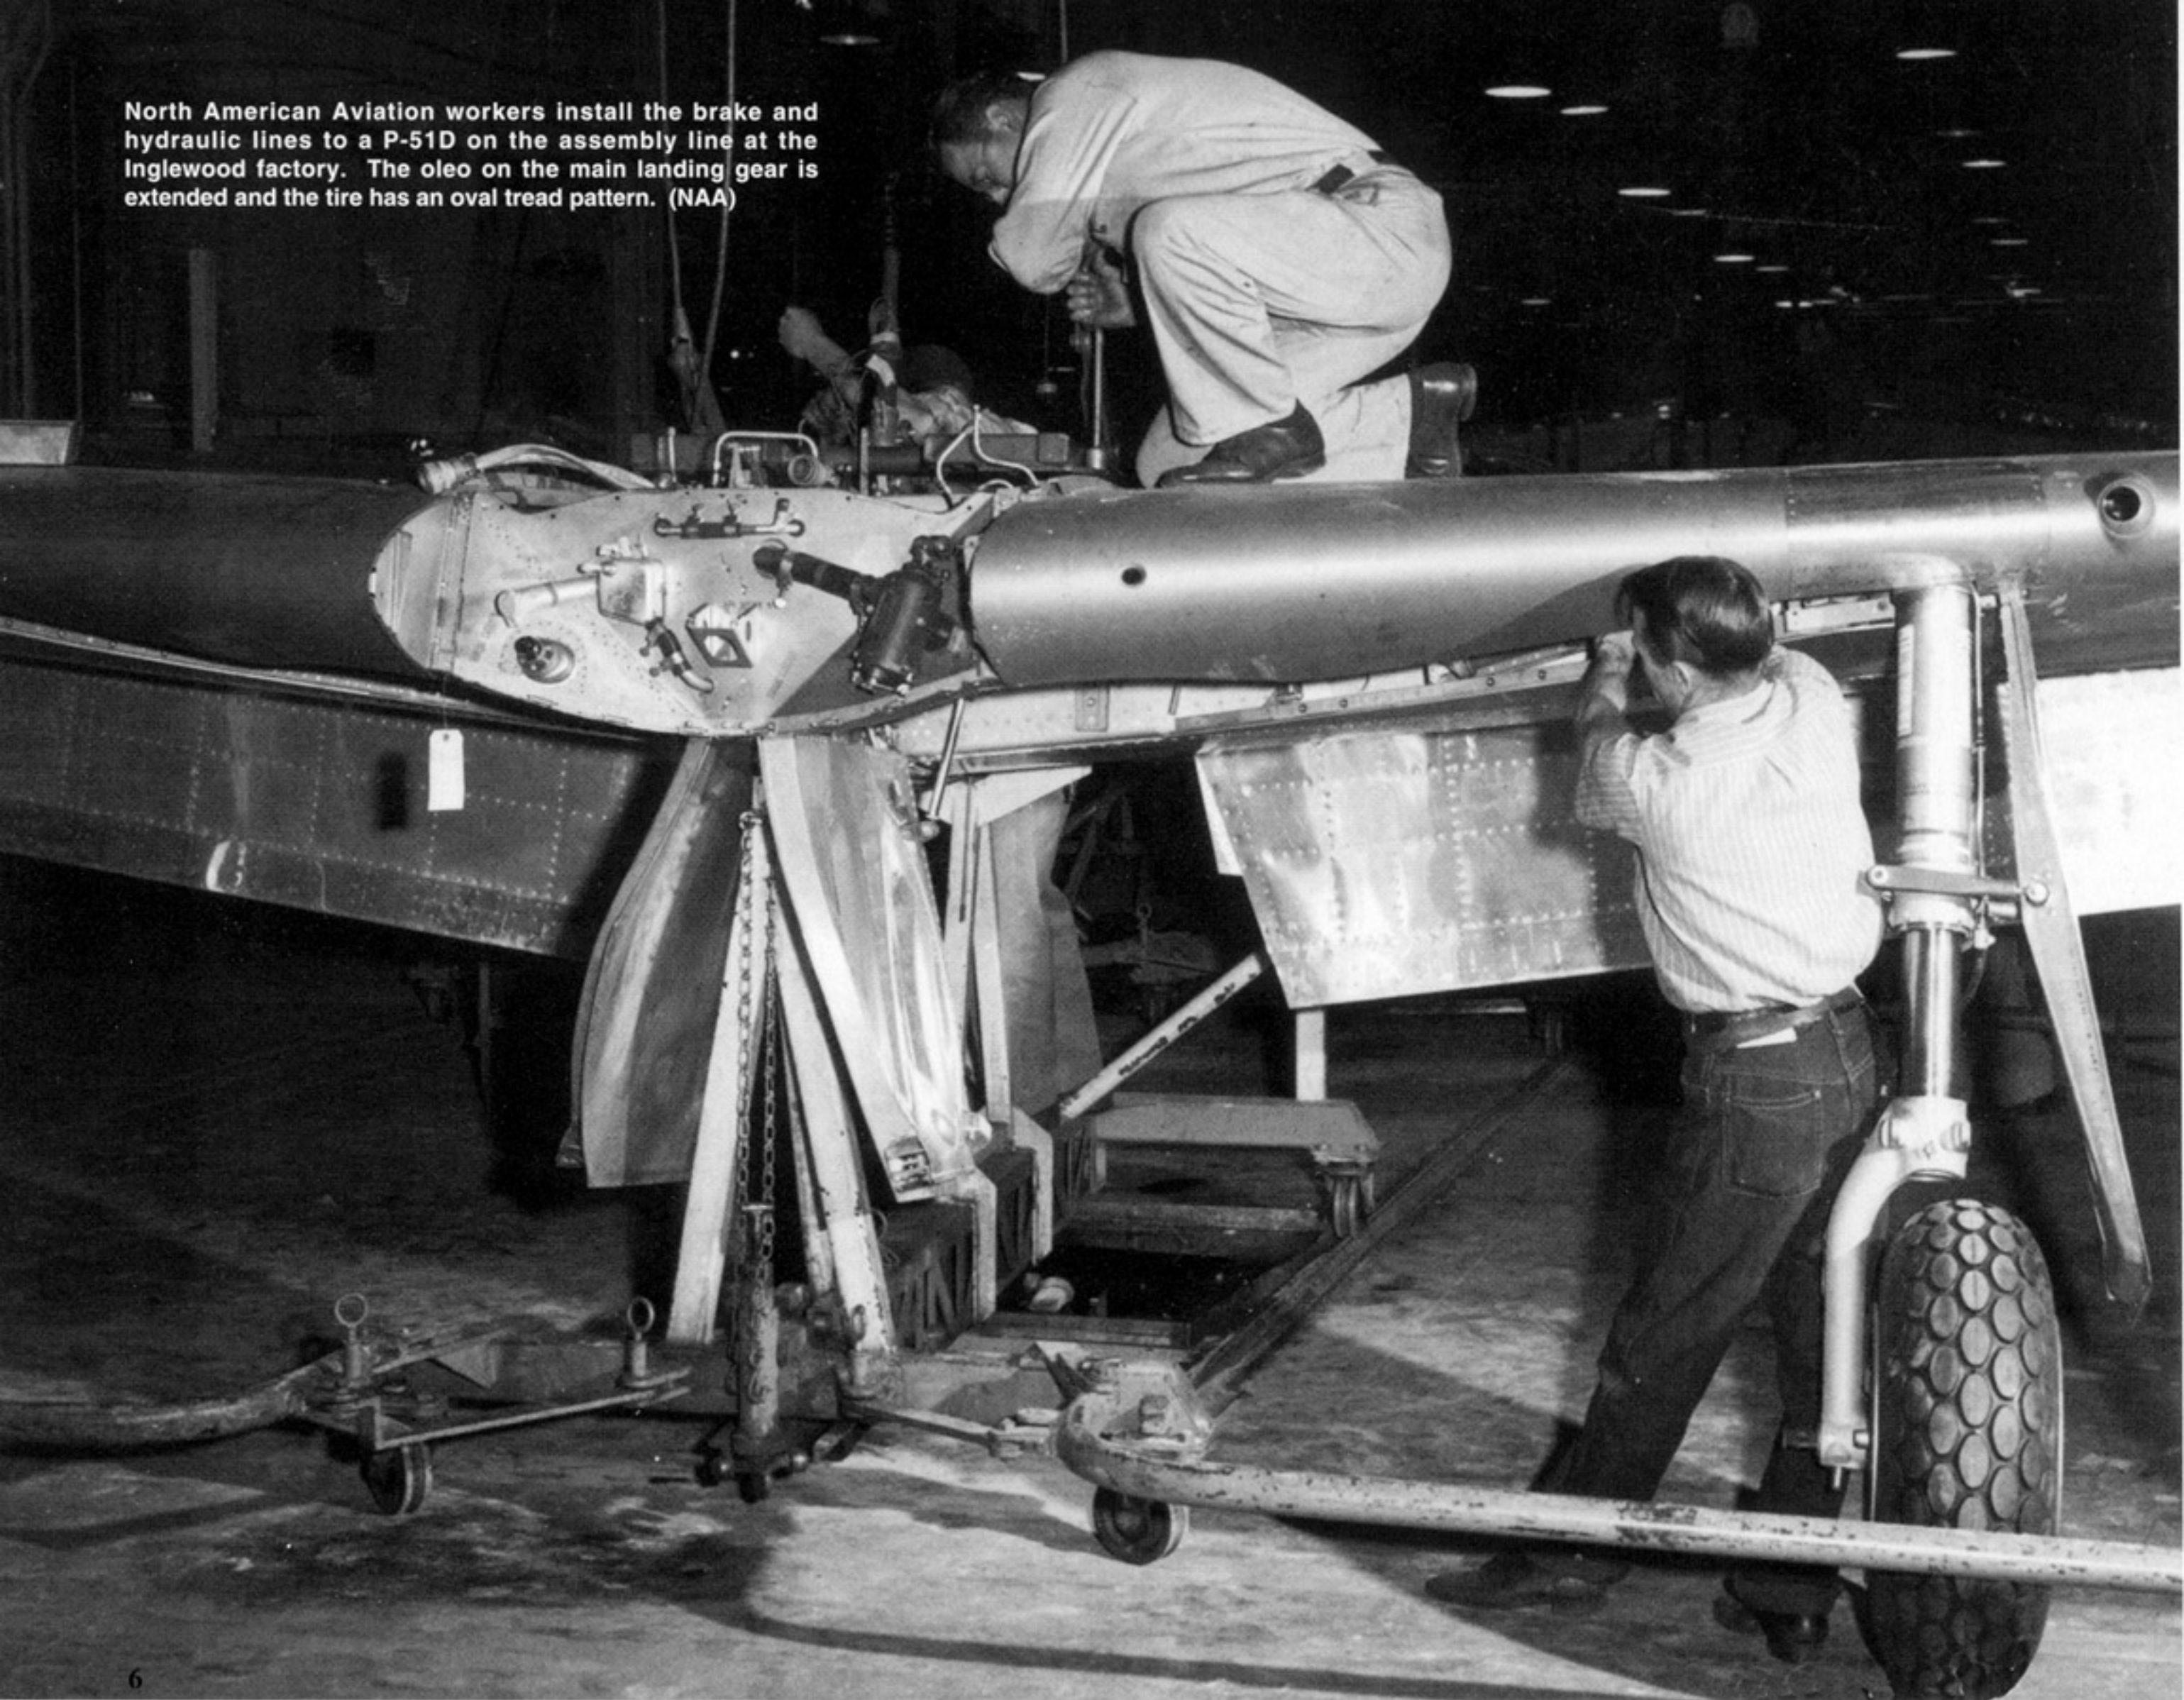
North American Aviation workers install the brake and hydraulic lines to a P-51D on the assembly line at the Inglewood factory. The oleo on the main landing gear is extended and the tire has an oval tread pattern. (NAA)

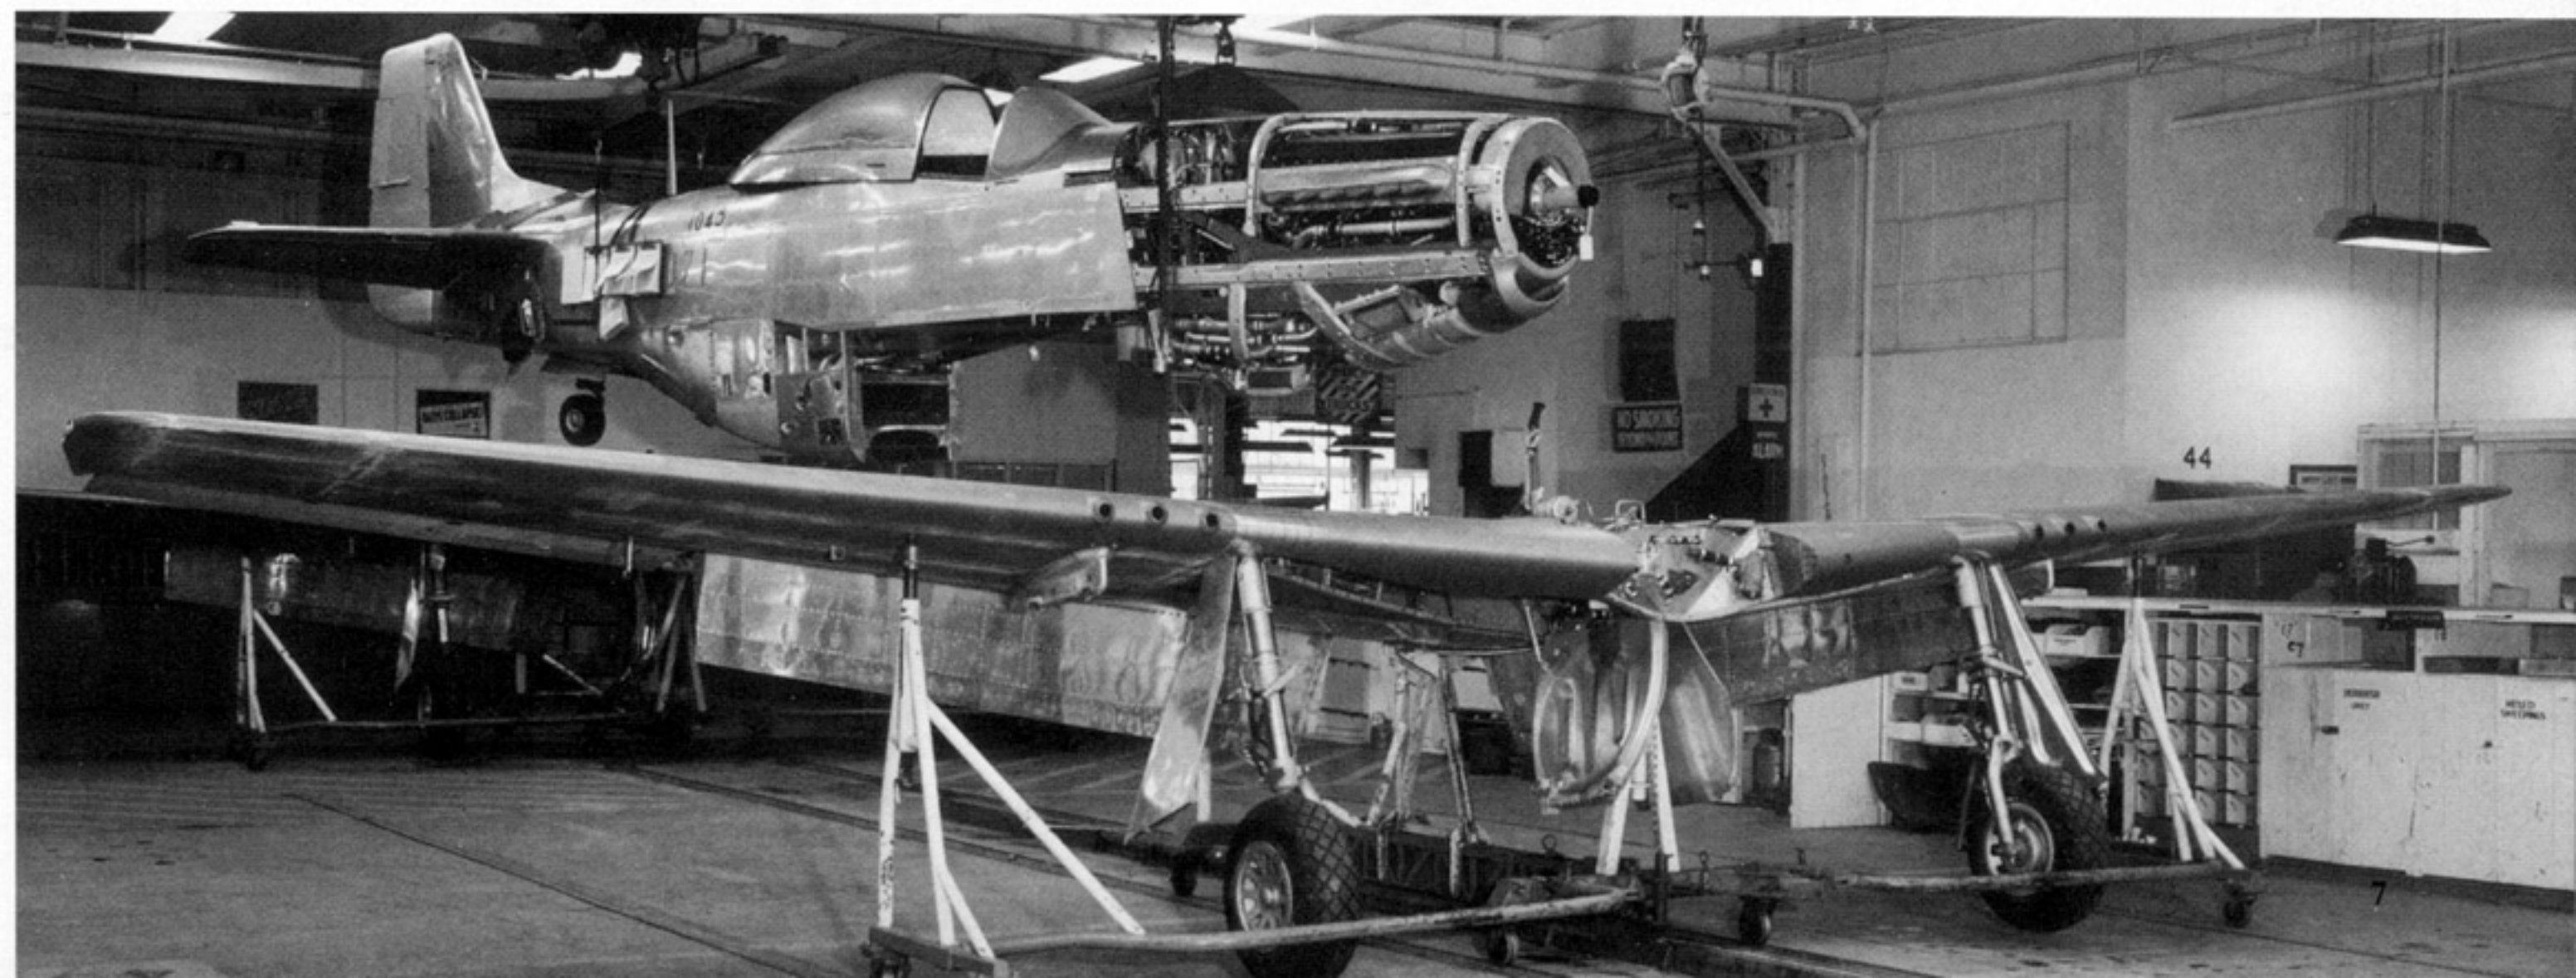
At this point in the production line, the almost completed fuselage is joined to the wing assembly, almost exactly the same way the model kits are assembled. The radiator intake and the engine access panels have yet to be installed. (NAA)

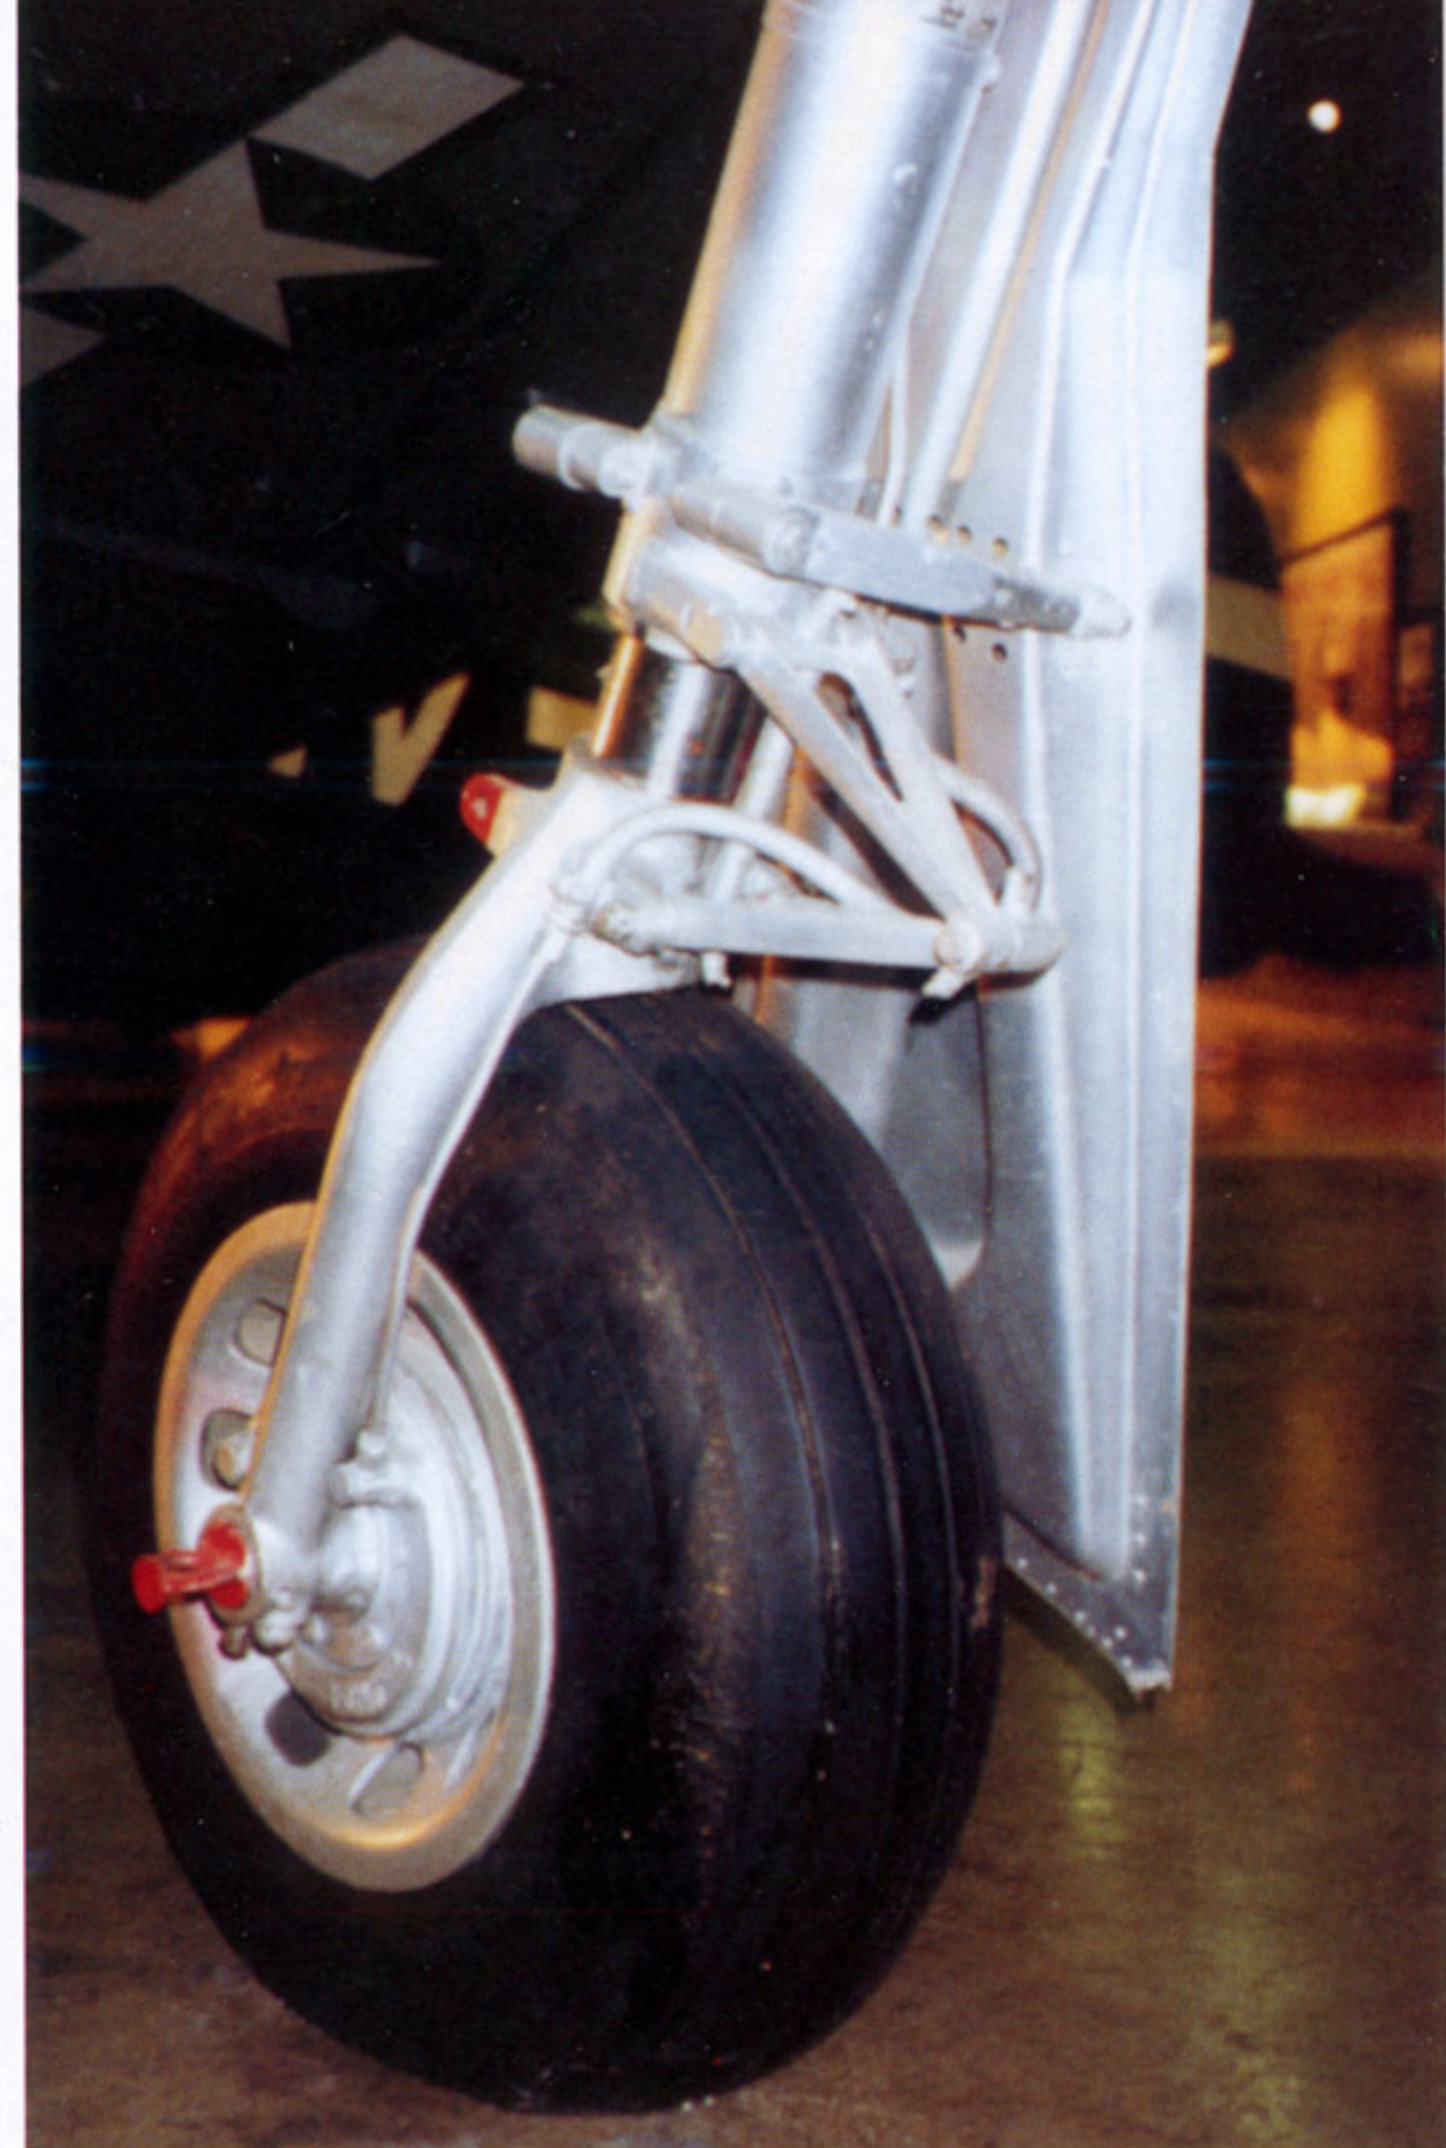
The complete inner starboard main landing gear assembly, which is identical in all respects to the port landing gear assembly. The landing gear struts were usually painted Silver at the factory to retard corrosion.

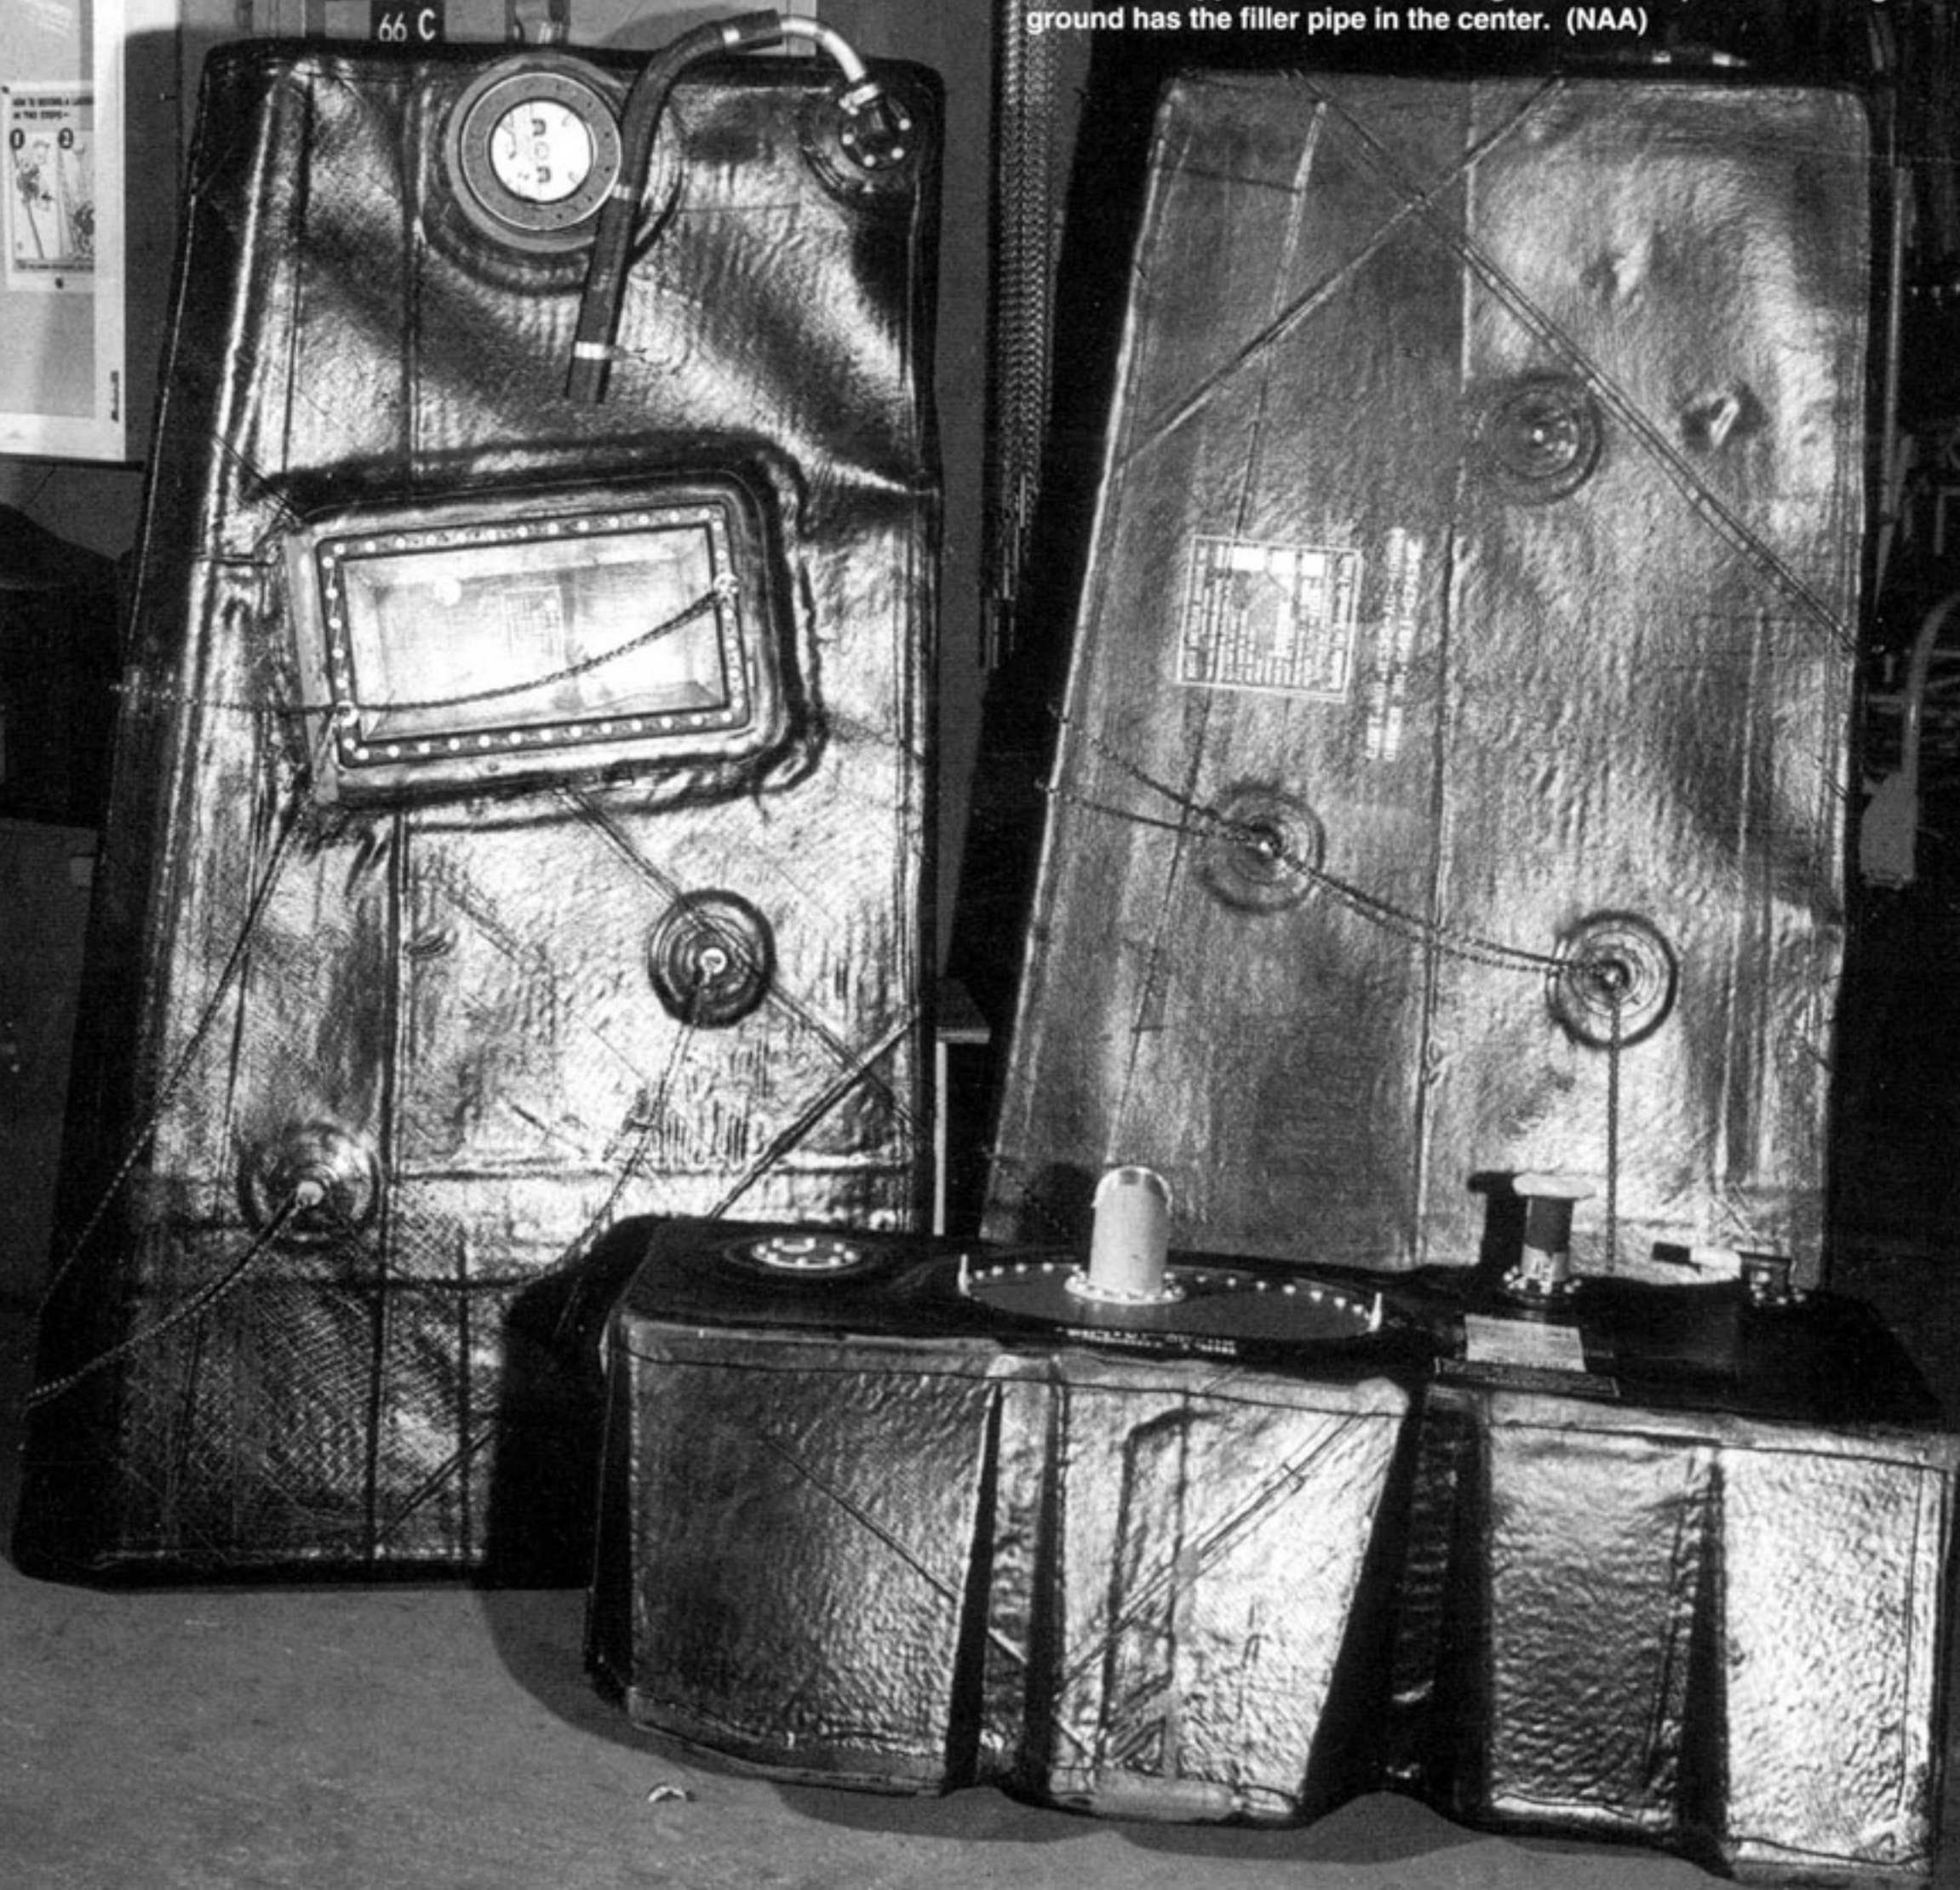
The self sealing rubber fuel tanks for the P-51D included two ninety-two gallon wing tanks, and a single eighty-five gallon fuselage tank. The tank on the left shows the upper surface and wing fuel filler cap. The fuselage tank in the foreground has the filler pipe in the center. (NAA)

The self-sealing fuel tanks were mounted into the wings from the underside. The ninety-two gallon wing tanks were manufactured specifically for the P-51D/K by U.S. Rubber Company in Los Angeles, California. (NAA)

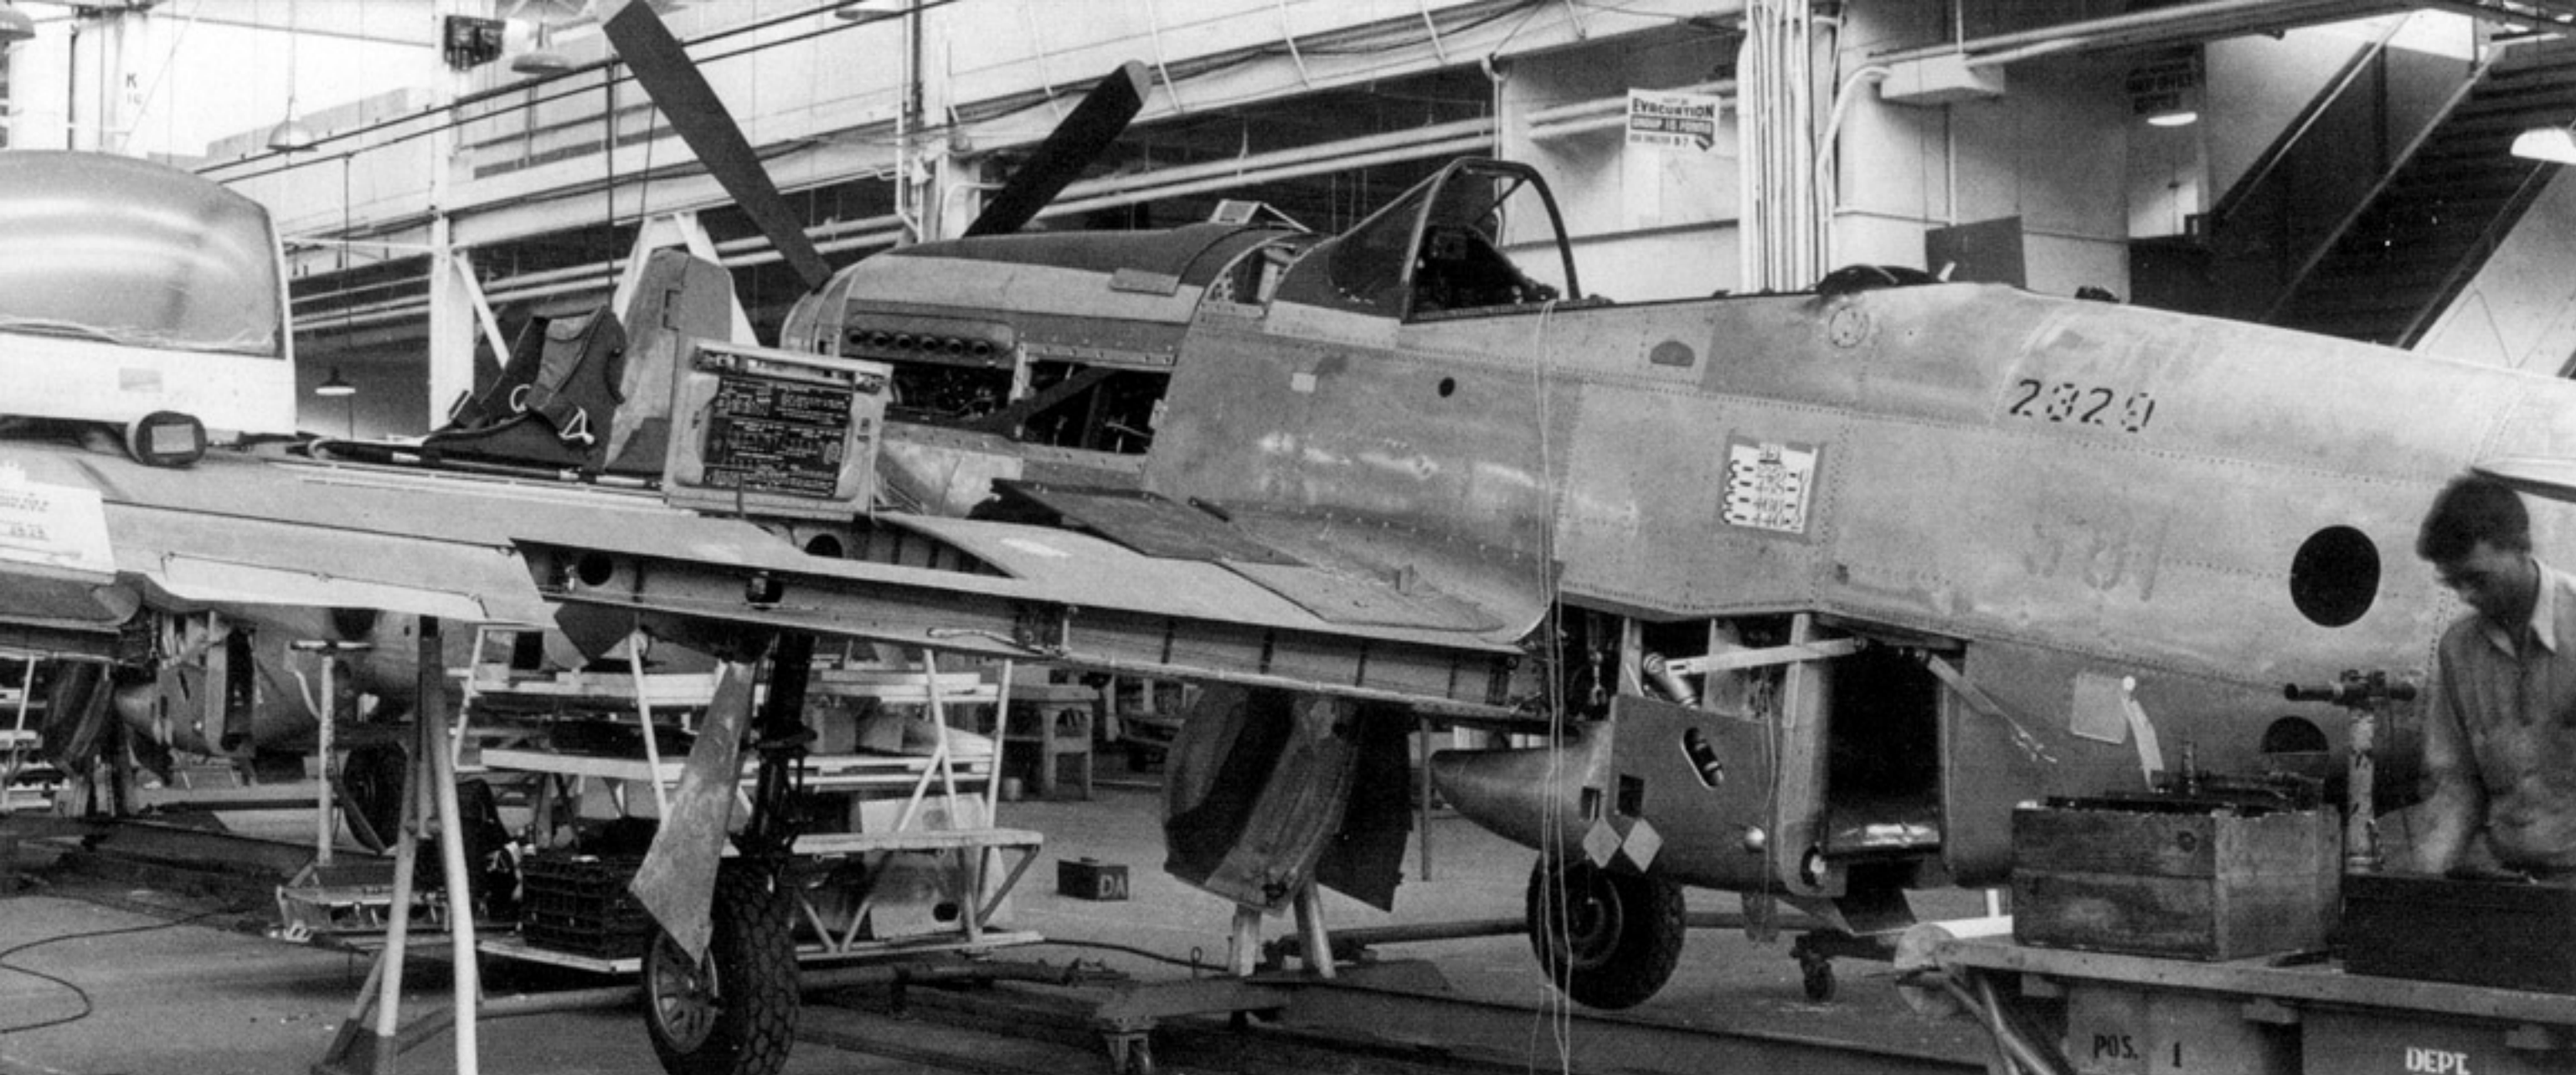
The forward part of the starboard main landing gear bay reveal a mechanical actuator, cables and landing gear up lock.

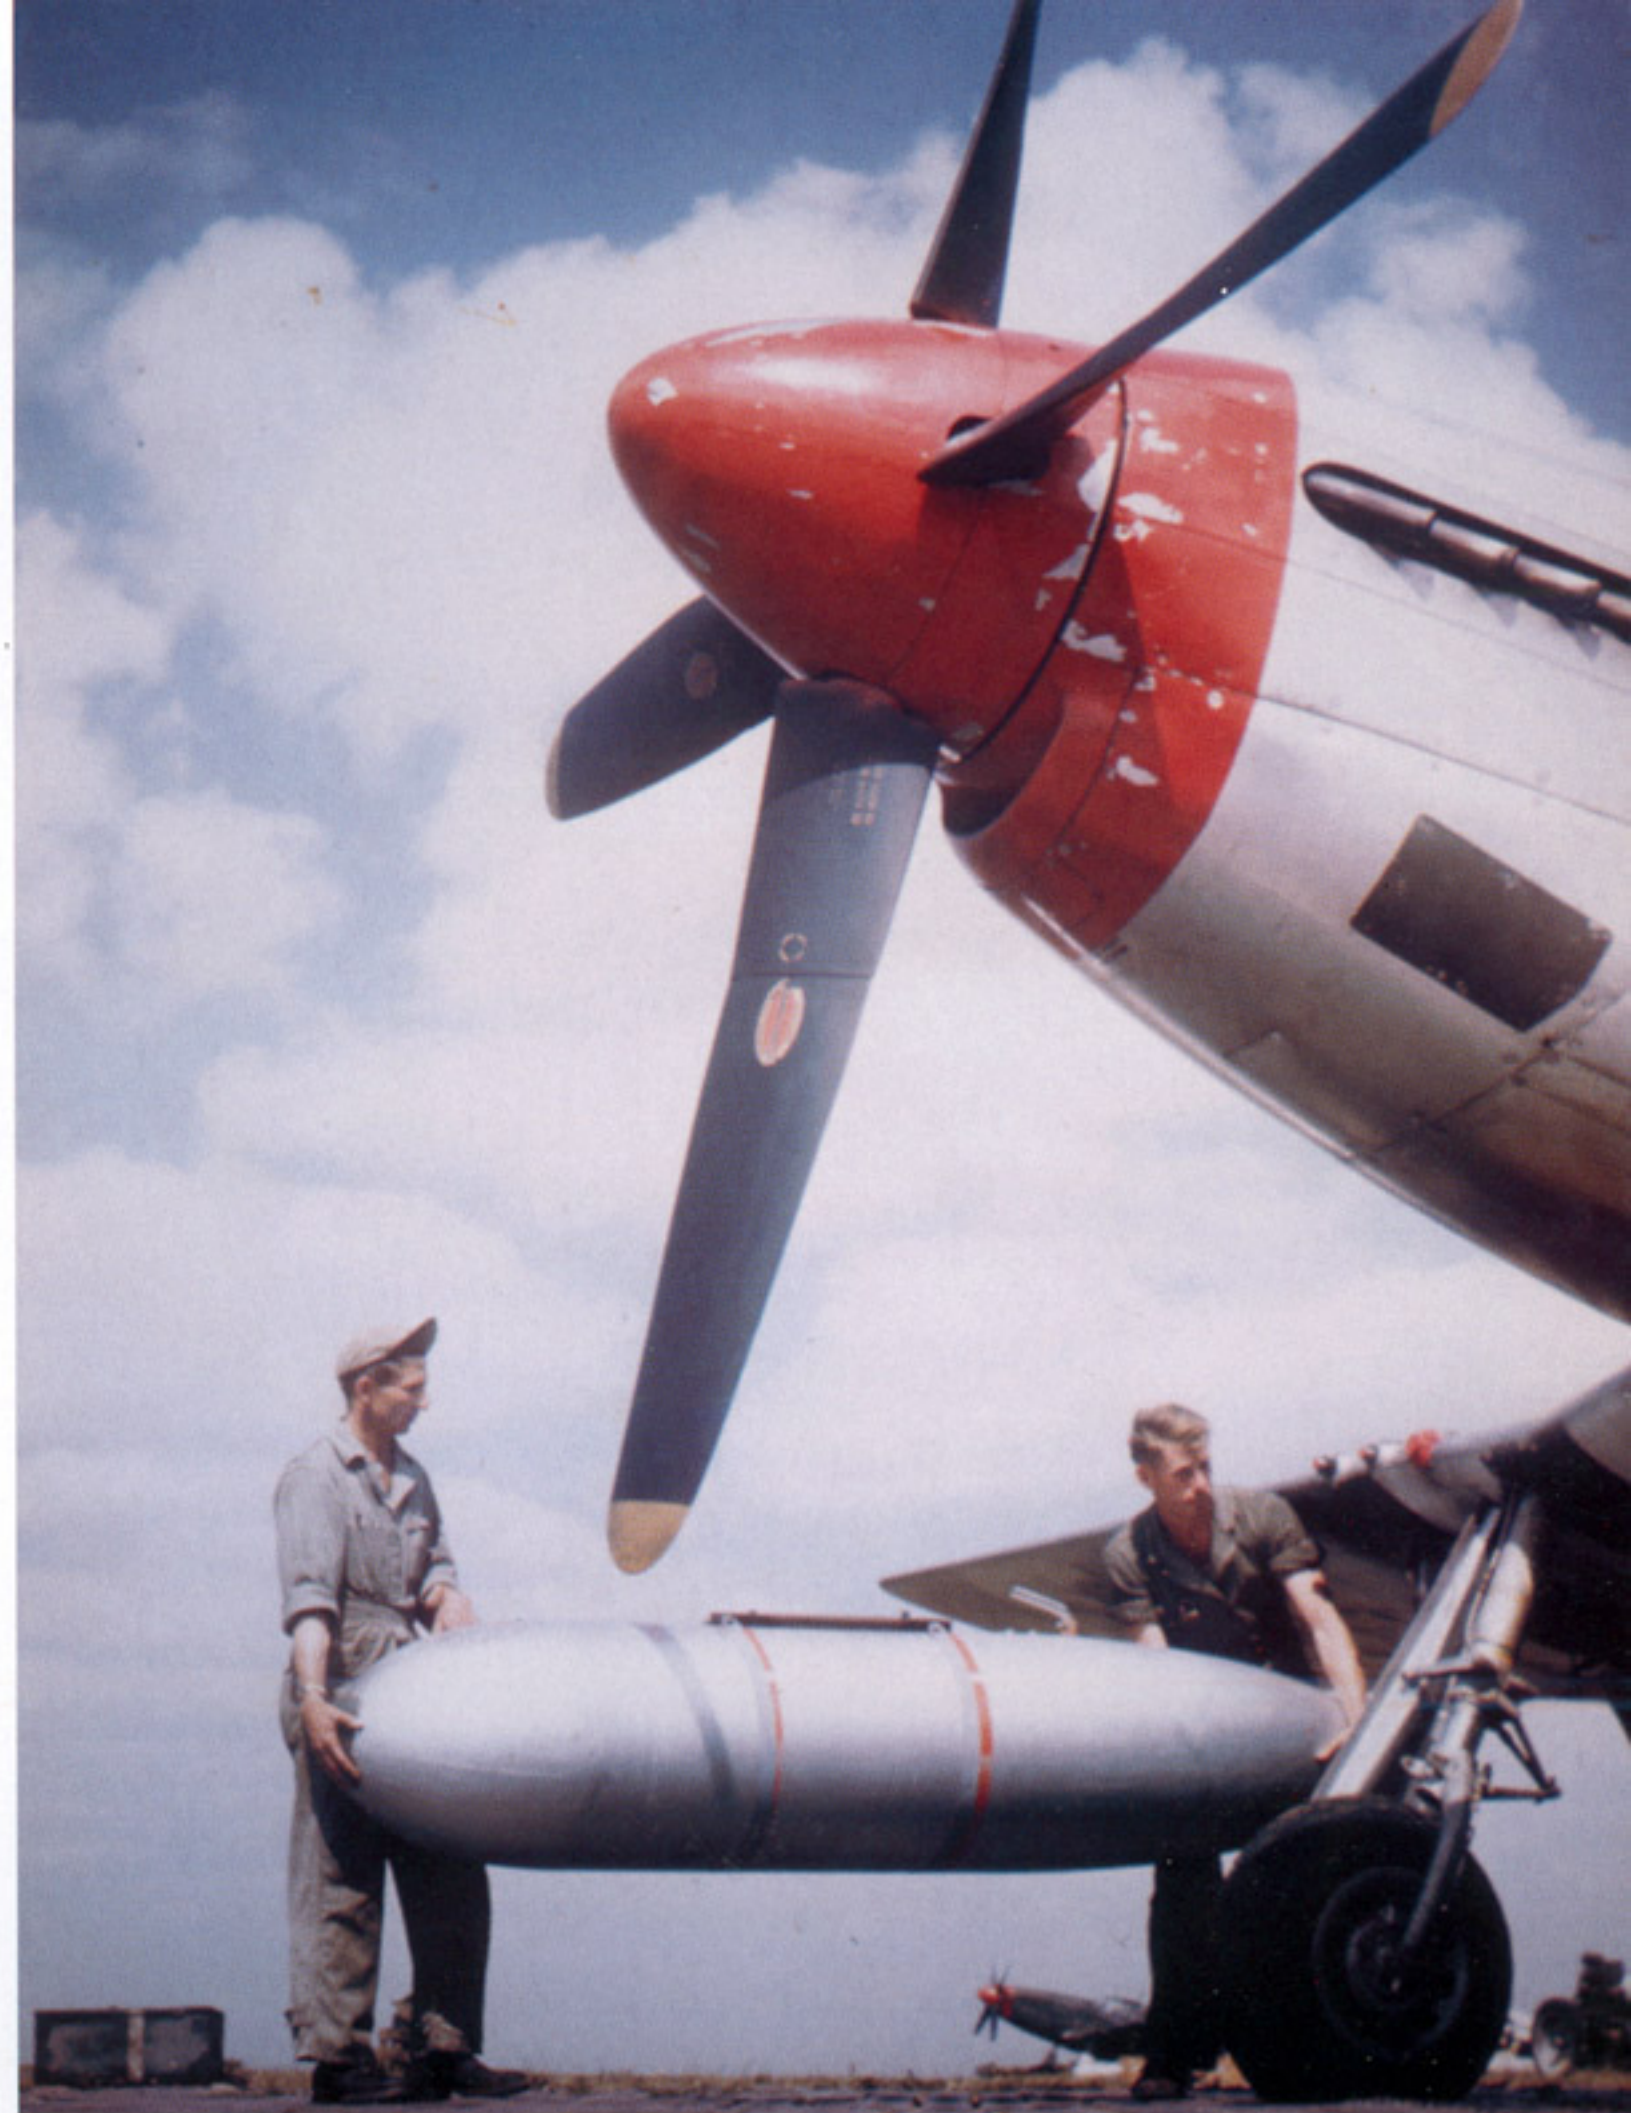
8th Air Force personnel unwrap stacks of brand new 108 gallon pressed paper drop tanks during 1944. Thousands of these and other metal drop tanks, both Allied and German, were dropped on Europe. The tanks were jettisoned as soon as an enemy aircraft was sighted. (via Jeff Ethell)

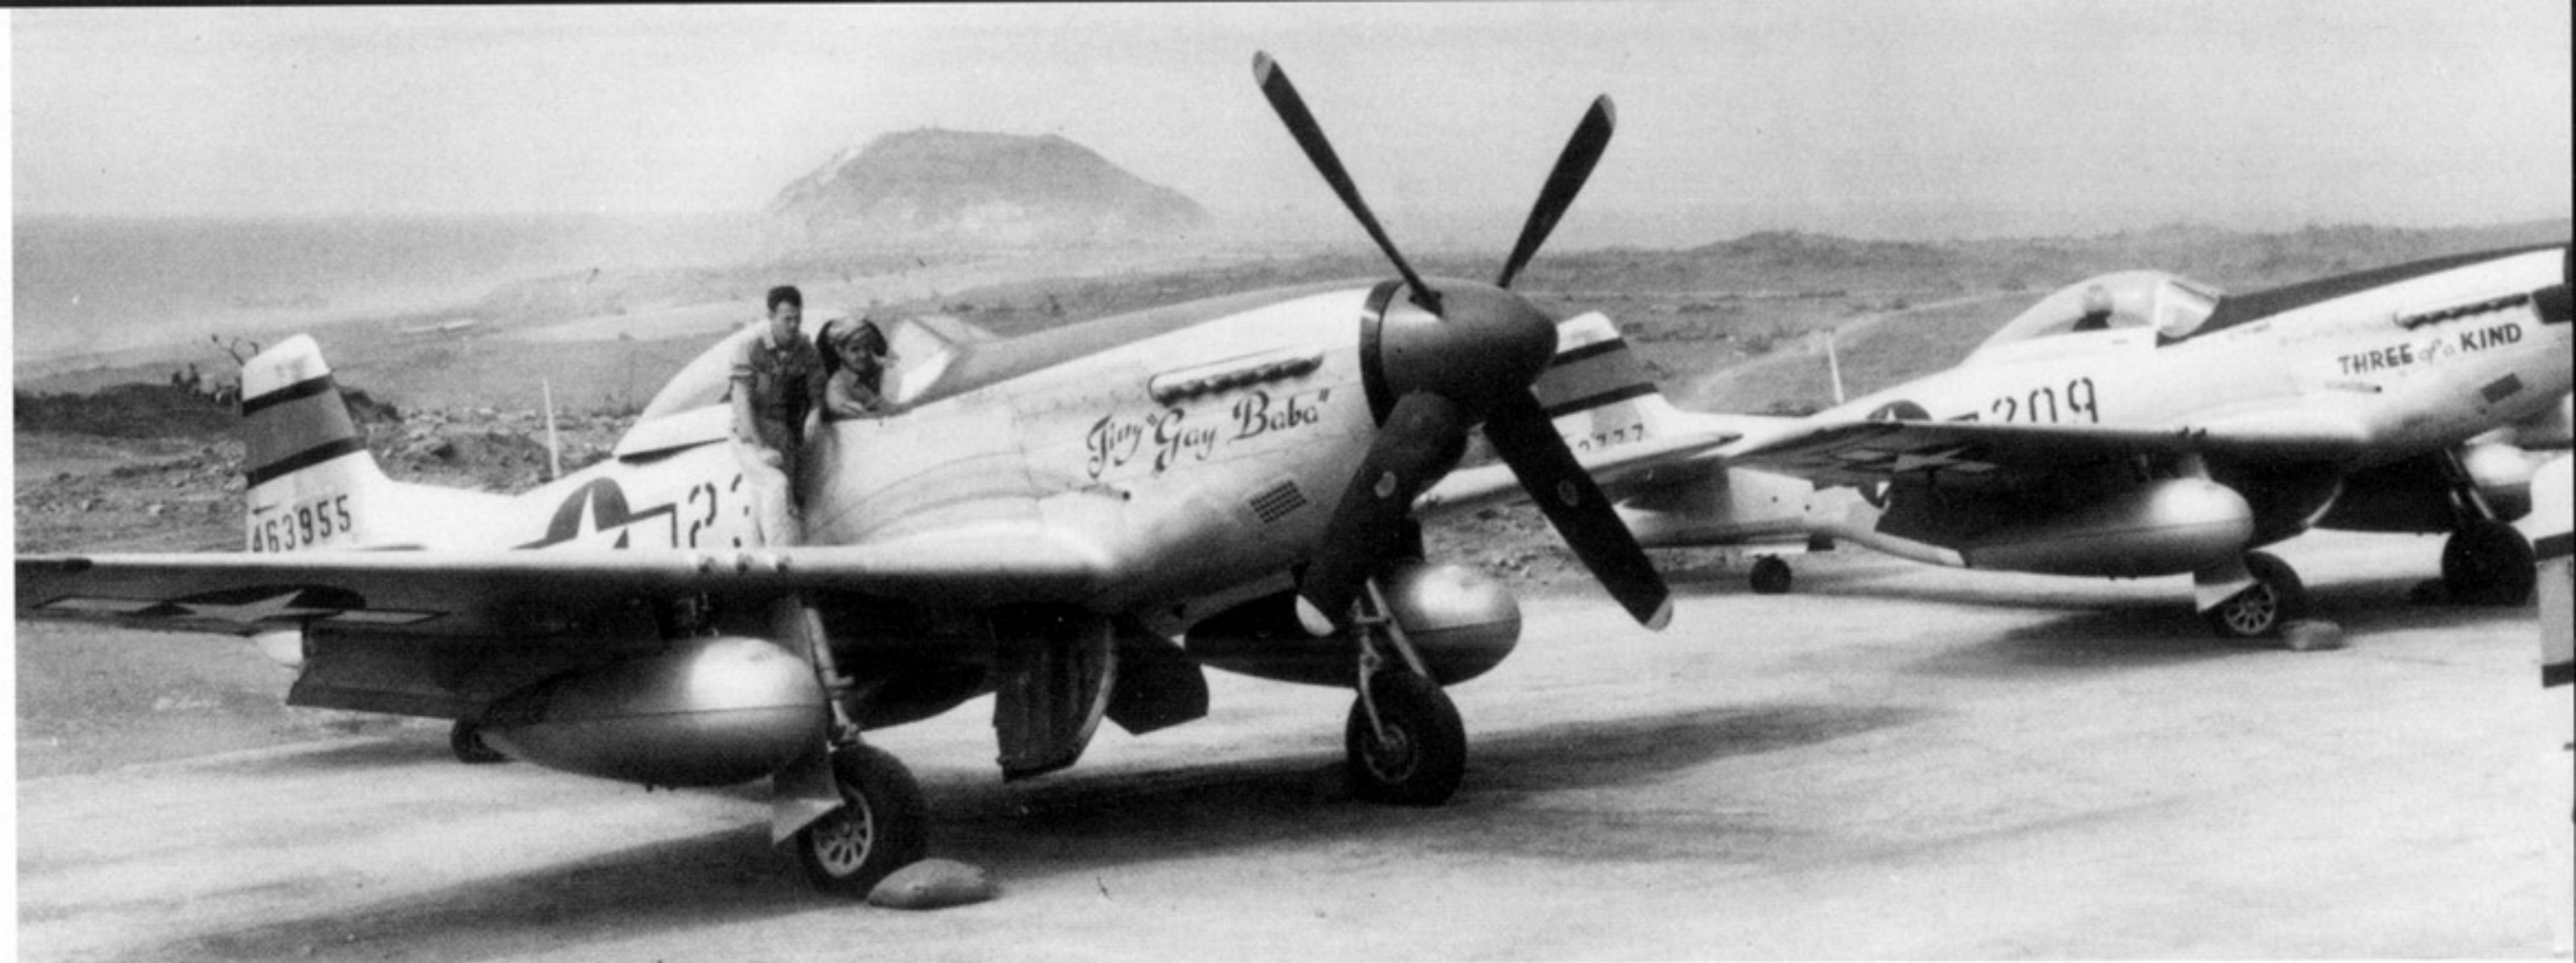
These P-51Ds from the 46th FS each carry a pair of the 110 gallon metal drop tanks developed for the Mustang. The 110 gallon tanks had external sway brace plates in addition to the standard pylon sway braces. (USAAF)
